The Solid Particle Erosion of Polycrystalline Diamond at High and Low Temperatures

This dissertation is submitted for the degree of

Doctor of Philosophy

September 2019

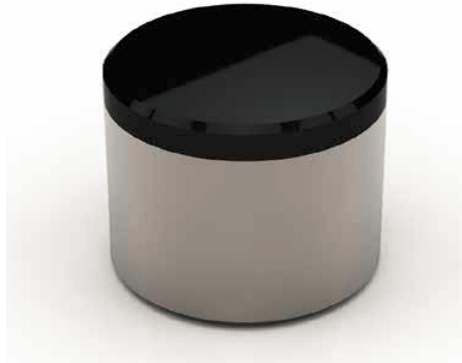
Fig. 1.1 An Element Six PCD compact. The 2 mm thick black PCD layer is integrally sintered to a tungsten carbide substrate. A range of diameters are available up to 70 mm, although 10 mm to 16 mm is standard for drilling applications.

Diamond was first synthesized in a controlled manner in 1955 by researchers at General Electric [4]. Although it immediately found an application as a loose abrasive, just as natural diamond had before it, the use of single crystal diamond for machining and drilling is limited by the highly brittle nature of the material, as, due to the lack of energy absorption mechanisms such as dislocation motion, it can fracture in tension under relatively small forces. In 1970, diamond grains were combined in a high pressure and high temperature environment for the first time to form a polycrystalline material [5, 6]. Since then, PCD has been manufactured for uses in drilling in the form of a thin 1 mm to 2 mm layer on top of a tungsten carbide-cobalt (WC-Co) substrate, known as a polycrystalline diamond compact (PDC), an example of which is pictured in fig. 1.1. PDCs have, since their invention,

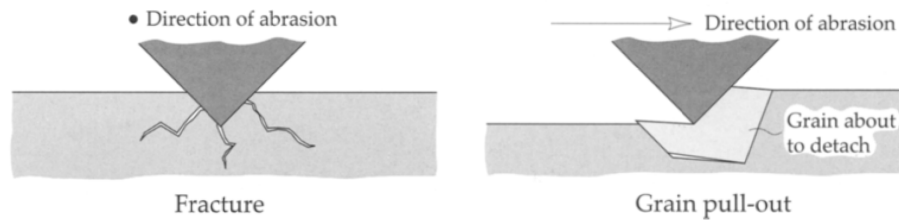
Fig. 3.6 Adapted from [103]. Two mechanisms of abrasive wear in brittle materials.

Abrasive wear can be sub-categorised into two modes, two-body and three-body wear. In two-body abrasive wear, hard asperities or rigidly held grits pass over the surface like a cutting tool [103], whereas in three-body wear the grits can roll or slide over the surface, typically resulting in a reduced rate of material removal [104, 105]. For both modes, Stachowiak & Batchelor [103] provide two mechanisms for abrasive wear in brittle materials, shown in fig. 3.6, with the grain pull-out mechanism more prevalent in materials with weak grain boundaries.

Erosion is expected to occur via the mechanisms described earlier in this chapter, whereby cracks caused by either blunt or sharp loading propagate into the surface and intersect to cause mass loss. Crack development and expansion during erosion can be directly compared to Stachowiak's example of abrasion-caused fracture in fig. 3.6, with the modification that

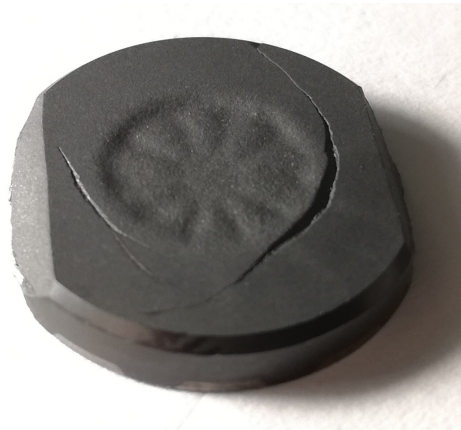
Fig. 5.4 The sample sintered at 5.5 GPa and a nominal 1450 °C after a single increment of erosion. A large mass loss was removed during the previous abrasive wear test, and erosion has formed cracks in the surface and eroded in a pattern. The 10-fold rotational symmetry of the erosion scar matches that of the PCD/WC-Co interface.

The sample sintered at a nominal 5.5 GPa and 1400 °C suffered extensive damage on the very first erosion increment, to the extent that no further erosion was performed (fig. 5.4). The damage pattern on the surface showed a pair of cracks surrounding the erosion spot, and a symmetrical pattern of damage within the spot. The high erosion susceptibility appears to be due to the sintering process being incomplete. The symmetry of the erosion scar matches that of the undulating PCD/WC-Co interface and areas further from the WC-Co substrate have been preferentially eroded, suggesting that there has been a lack of cobalt flow during

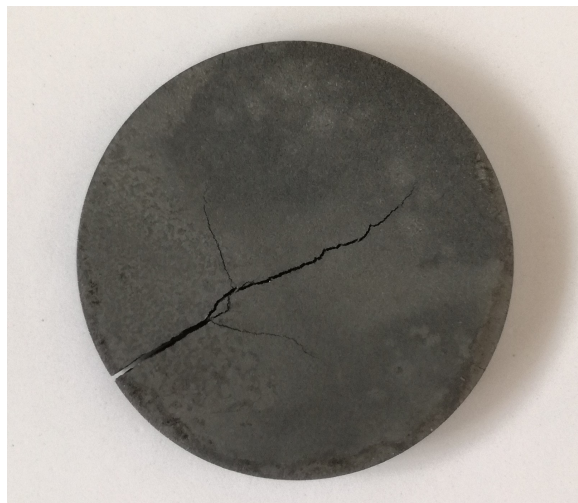
Fig. 5.10 A G30 PCD disc after a 1 h heat treatment at 850 °C, showing a crack running through the centre of the disc which excluded it from further experiments.

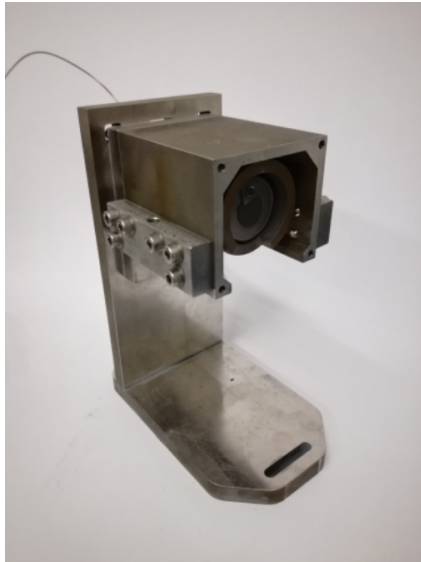
(c) An early version of the sample holder mounted within the box.
